HSS compliance – roof issues and moisture

Larry Russen
Chartered Building Surveyor

2025

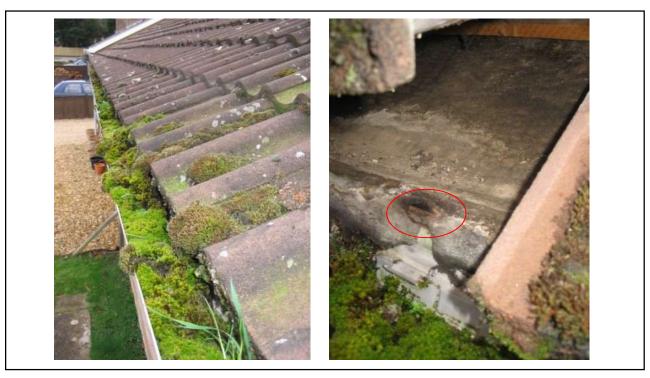
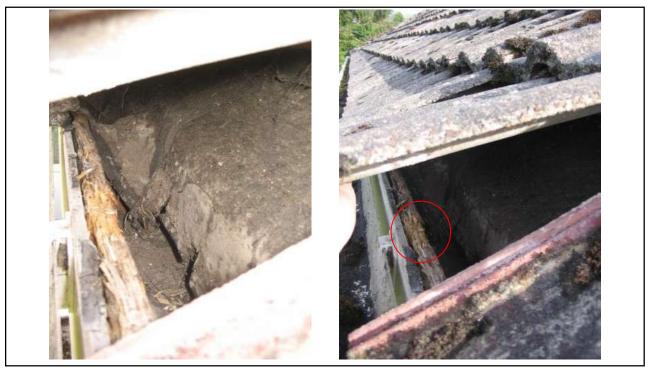
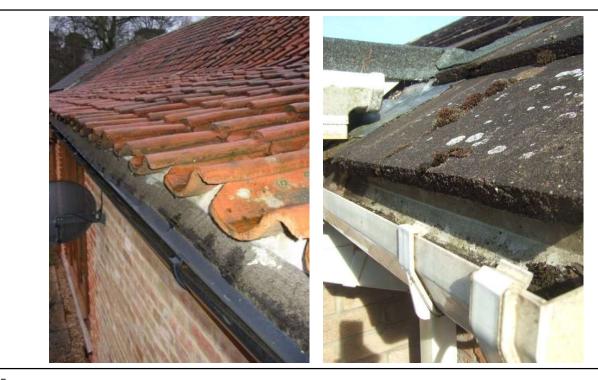
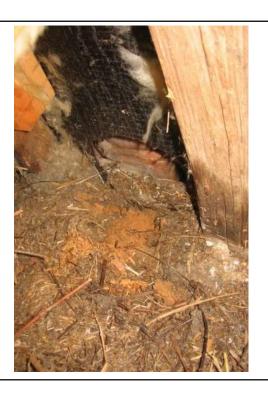
Eaves underlay – what it looks like in practice

- With some coverings, birds will peck at the felt for nesting material, particularly at the eaves
- This can allow significant water ingress to occur

- Watch for defects caused by sag in felt immediately behind fascia, UV light and tiles or slates rubbing on felt above the fascia
- Causes rot in joist ends, fascia, soffit and supporting timbers
- If you can see daylight between gutter and fascia, perhaps the underlay isn't dressed into gutter?
- Diagnose by checking for water staining to fascia or soffit, getting down into eaves internally, propping ladder against gutter (these also fail due to UV!) and lifting tile(s) – watch out for birds
- Remedial action strip back tiles, battens and felt, repair or replace rot, lap in new polymer felt, re-batten and re-tile
- Cost this can be very expensive, particularly if the work is at first floor
- "Top tip" look out for plastic fascias planted on the face of the old, rotten, softwood fascia; "old" felt will fail on south side of a building within 7-10 years

Failure of the underlay material (felt) at the lower edges of the roof is particularly bad because felt has sagged beneath the lowest row of tiles, behind the gutter. This allows water to collect in the sagged trough of the underlay. If the sagging underlay fails or has holes in it, water can run down into the wall or onto timbers. This can cause fungal decay (rot). This problem is especially associated with a roof with a shallow slope (pitch), such as this roof. [delete] The problem can be prevented if there is a piece of timber or plastic beneath the lowest piece if underlay (called a 'tilting board' or 'fillet'), immediately behind the gutter, to prevent the underlay sagging. There is no tilting board on the roof of this property. [delete]

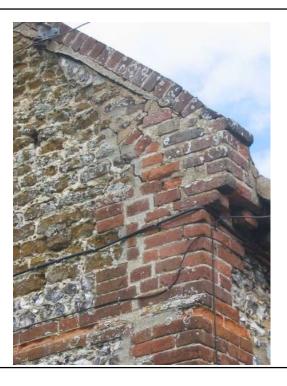
Slipping of coping on sloping parapet, particularly where there is a DPC, which becomes a 'slip joint'

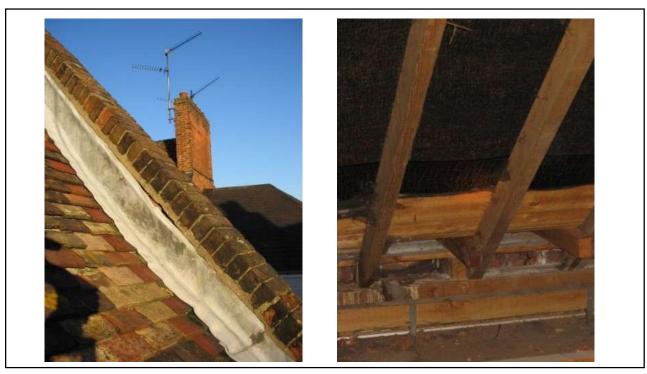
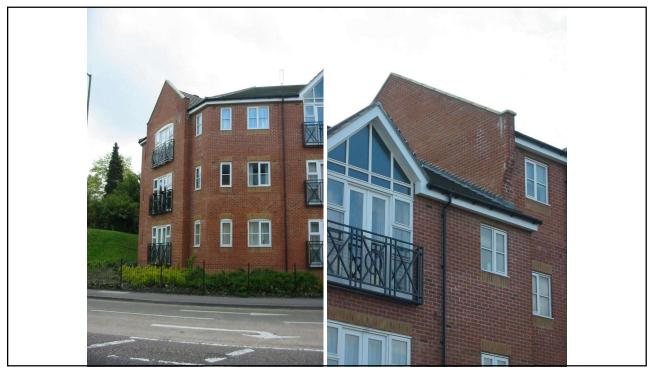
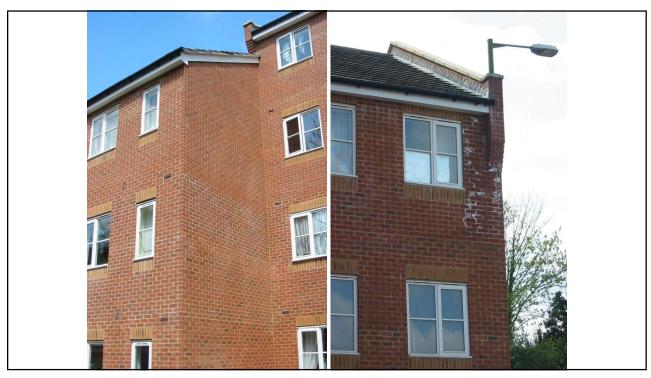
- Gutter outlets through the parapet are particularly prone to problems occurring
- The outlet also creates a weak point in the parapet

• Such a wall should have at least one damp-proof course to help prevent water penetration. However, damp-proofing to parapet walls is difficult for builders to achieve and is therefore sometimes incorrect. This can allow water penetration to occur. Some water penetration may occur in the future. Water penetration can cause rot (fungal decay) in timbers in the property and deterioration in plaster and decorations. The coping should have a groove (throat or drip) in the lower side beneath to help prevent damp penetration.

• The parapet gutter has a lead / felt / asphalt / [other] [delete] internal lining. Such a gutter should be correctly designed and laid, e.g. with steps and a flashing at the joint with the adjoining parapet wall. This is because it is a vulnerable position in a building – rot (fungal decay) attacks beneath a parapet gutter are very common. Such a gutter requires regular maintenance including clearance of leaves and debris, particularly to help ensure the outlet through the parapet wall into the gutter is kept clear, otherwise water penetration can occur. Water penetration can cause rot (fungal decay) in timbers in the property and deterioration in plaster and decorations.

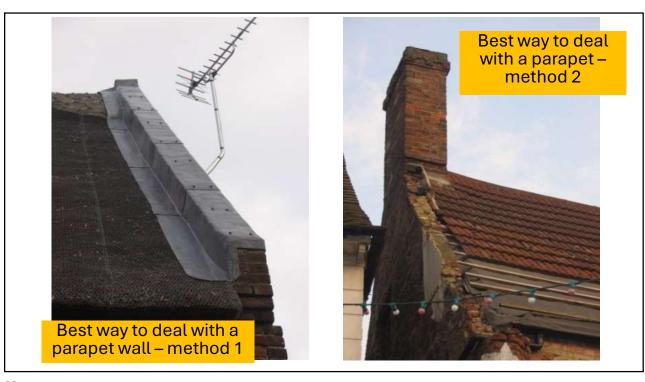
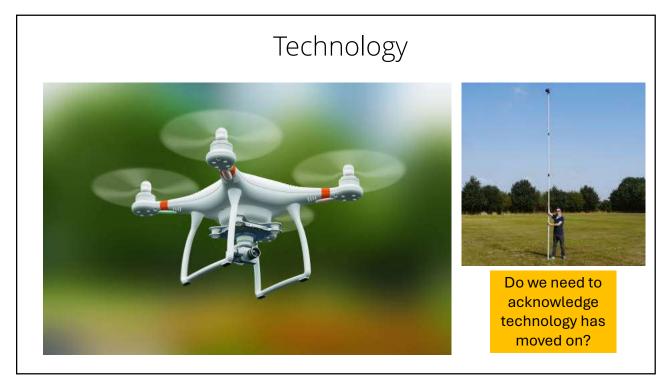
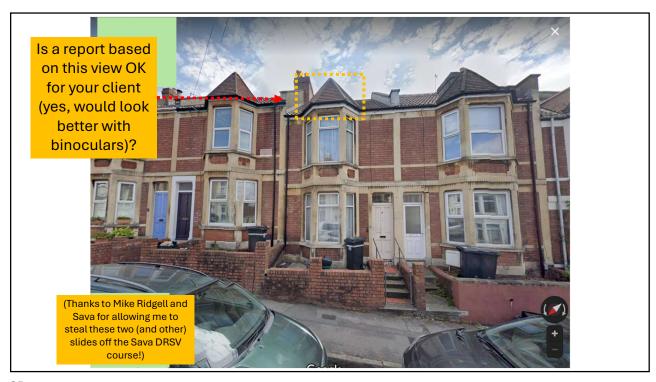
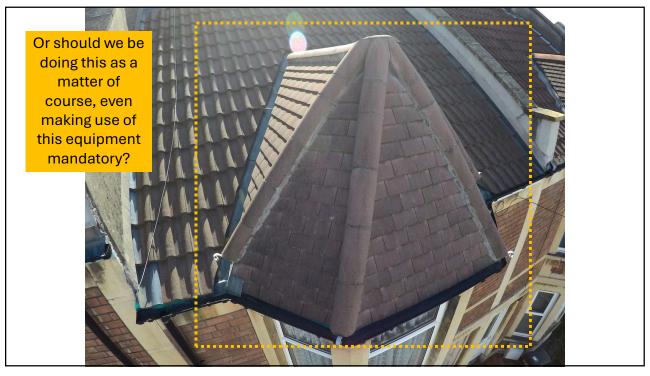
• Over the years water penetration into the wall and areas beneath a parapet can lead to significant problems. There is usually an important timber (called a 'wall-plate') that helps support the roof structure under the wall. This can slowly rot and collapse. It is usually expensive to replace this timber. The bricks / stones [delete] and pointing (mixture of sand, cement and or lime) in a parapet wall tend to deteriorate more quickly than in a 'normal' wall because of the exposure to water. Such failure can allow even more water penetration to occur. It is therefore very important to ensure any parapet wall is carefully and regularly maintained.

- Assume all parapet walls leak
- Inspect them very carefully outside with binoculars:
 - Bulging, rotation and leaning
- Get as close to them as you can in the roof space and use your moisture meter
- Beware condition of timbers in the wall or close by
- Use your moisture meter on walls in all rooms beneath the parapet
