HSS compliance 1 – best practice and structural movement

Larry Russen
Chartered Building Surveyor

2025

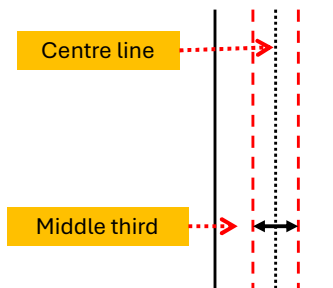
To assess the wall properly, the extent of the bulge needs to be assessed. The 'middle third' rule is often used. Although it is sometimes not practical to use this method on pre-sale surveys, understanding this approach can help you make broad based assessments and with practice, this method can help give you and your client a good approach to assessment.

If the centre line of a bulging wall falls outside the middle third, then the stability of the wall may be under threat.

Another way of thinking about the rule is if the wall is vertically leaning or bulging by more than one sixth of it's thickness, then stability may be threatened.

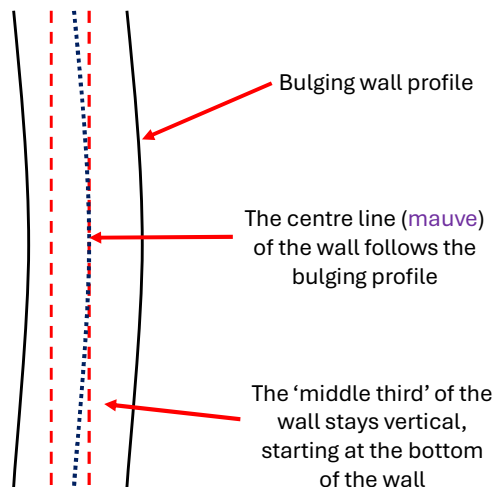
This diagram shows how the theoretical centre line of a bulging wall can fall outside the 'middle third' – Method 'A'

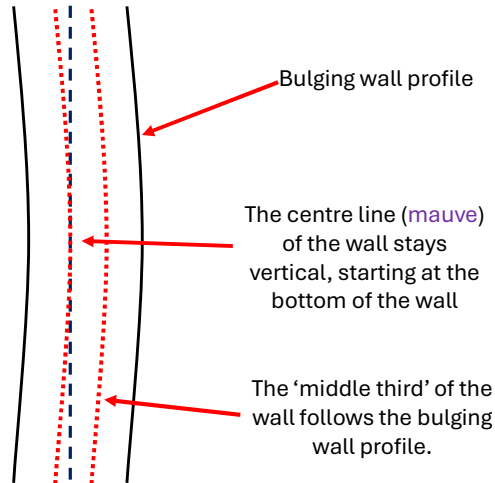
This diagram shows how the theoretical centre line of a bulging wall can fall outside the 'middle third' – Method 'B'

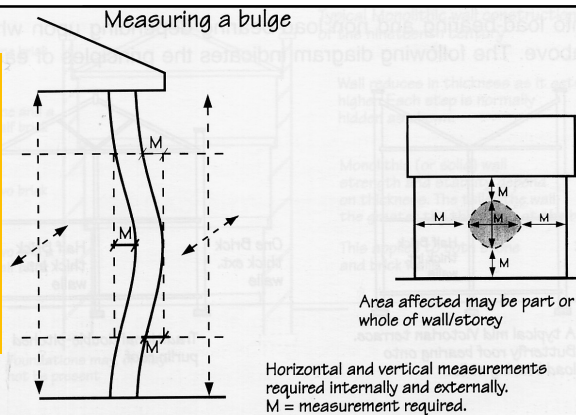
To properly assess the extent of the problem, precise measurements from a plumb line to the face of the wall must be taken. This data can be used to outline the 'contours' of the bulge and so help determine any remedial work

Example – for a 225mm thick wall, the width of the middle third will be 75mm:

If the wall is between 0 – 37.5mm out of vertical – it may not be a problem.

If wall is more than 37.5mm out of vertical – the wall may need restraining to stop it getting worse and possibly collapsing.

If wall is more than 75mm out of vertical, stability is likely to be threatened and significant works such as 'Helifixing', partial or complete rebuilding is likely to be required.

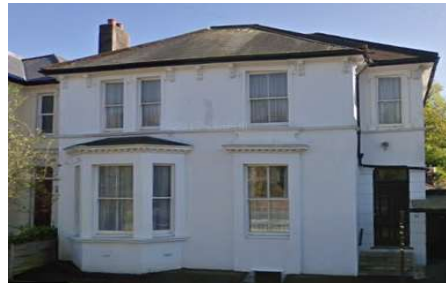
April
2009
Original

- This case relates to advice given by a Structural Engineer, following a referral for further investigation in a HBR (level 2 report) by a Chartered Surveyor.
- It relates to a property in Hastings that was ultimately demolished and rebuilt, because of the extent of structural movement, mostly tilt (or '*rigid body rotation*') it had suffered.
- Purchased 2011
- Rebuilt 2013 – 14

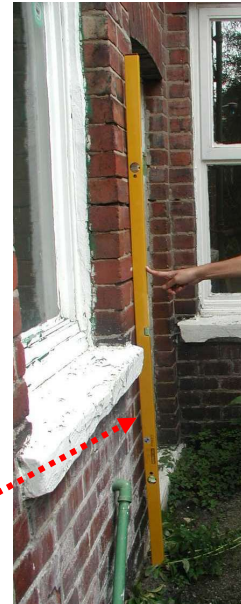
- In Scott v Sheppard the defence tried to discredit the measurements quoted by the claimant's engineer, because they were taken with a spirit level rather than a plumb bob. This was successfully defended by reference to BRE 343 & 344 which references spirit levels as suitable equipment.
- The Judge commented:
- *“The fact that there are other methods available does not mean that a spirit level does not give accurate, or broadly accurate, measurements. I find that in this case it was appropriate to measure the building in the way that Mr Taylor did.”*
- (Mr Taylor was the expert for the claimants)

Moral of the story – use one of these

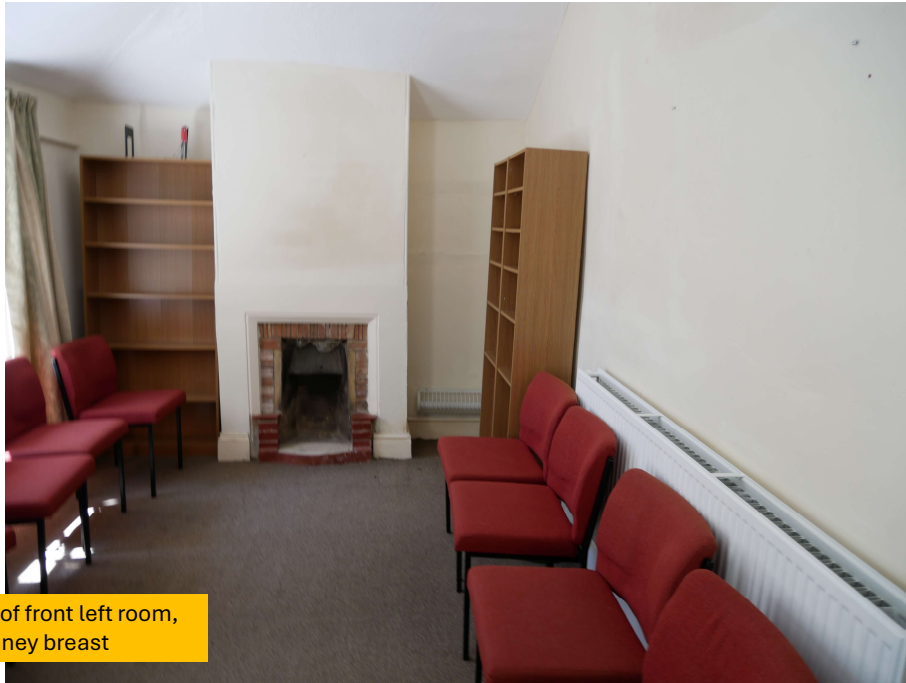
Inside view of front left room,
chimney breast

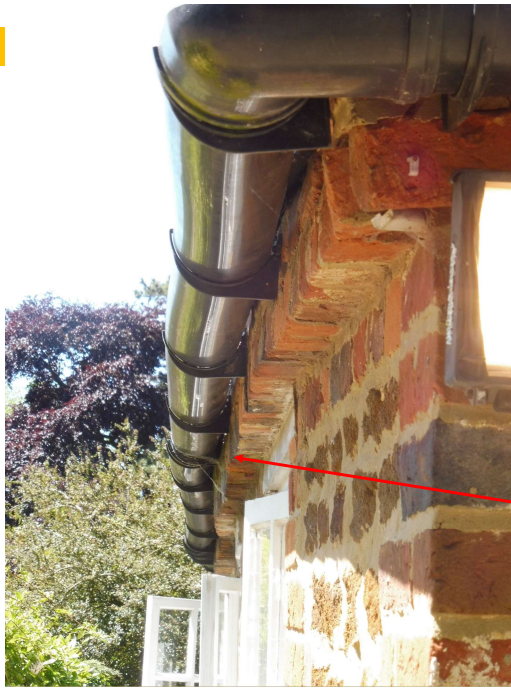
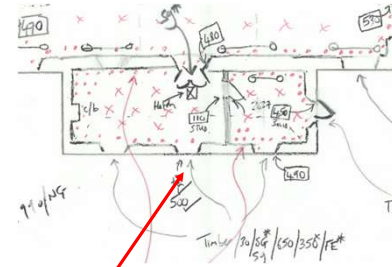
Case study 1

Front wall has
bulged at eaves
level

This can be seen by
looking along the
line of the gutter
and the top string
course of the wall

- The roof structure is not 'triangulated' (tie bar and pattress plates are not supporting the front wall);
- The ties to the roof structure are not in the lower '1/3', but in the middle '1/3';
- The 'A' frame roof structure has therefore distorted, and the feet of rafters and trusses have thrust outwards;
- Thereby causing the top of the wall to bulge; and
- The wall generally to lean outwards; so
- Movement is likely to progress, i.e. get worse; thus
- **Condition rating 3.**

The outside front wall of the extension has suffered distortion due to bulging and leaning. This is due to the roof structure pushing (thrusting) the top of the outside wall outwards. This has caused some distortion inside (to the ceiling and the walls) and outside. The movement is mainly associated with, and situated around, the weak points in the outside wall, i.e. window openings. In this regard, the works associated with the roof structures (see section dealing with the roof structure) must include further investigation to the lower edges of the roof to ensure the rafters are satisfactorily attached to the timber at the top of the wall, to help prevent further thrust occurring. That work is required now. I cannot yet confirm the exact nature of the work, but it might include, for example, introduction of further timber or metal tie beams, strengthening and improvements to other timbers and or substantial repairs at the bottom of the main tie beams and rafters. Condition rating 3.

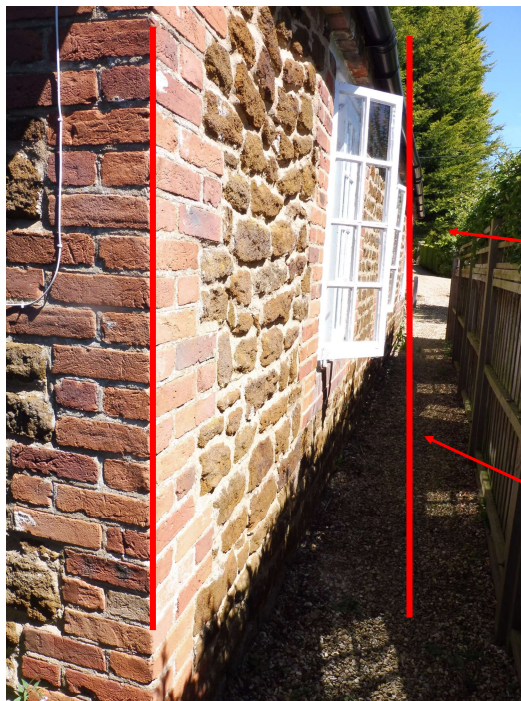
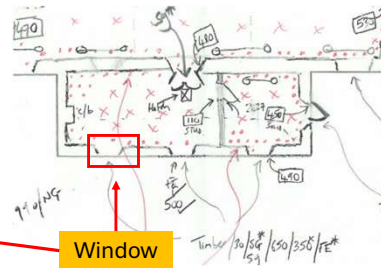
Window

Wall is bulging at eaves level
and therefore leaning
outwards

The lean has caused the
window sash to lean
outwards, when open

Total amount of bulge is
around 125mm at eaves
level

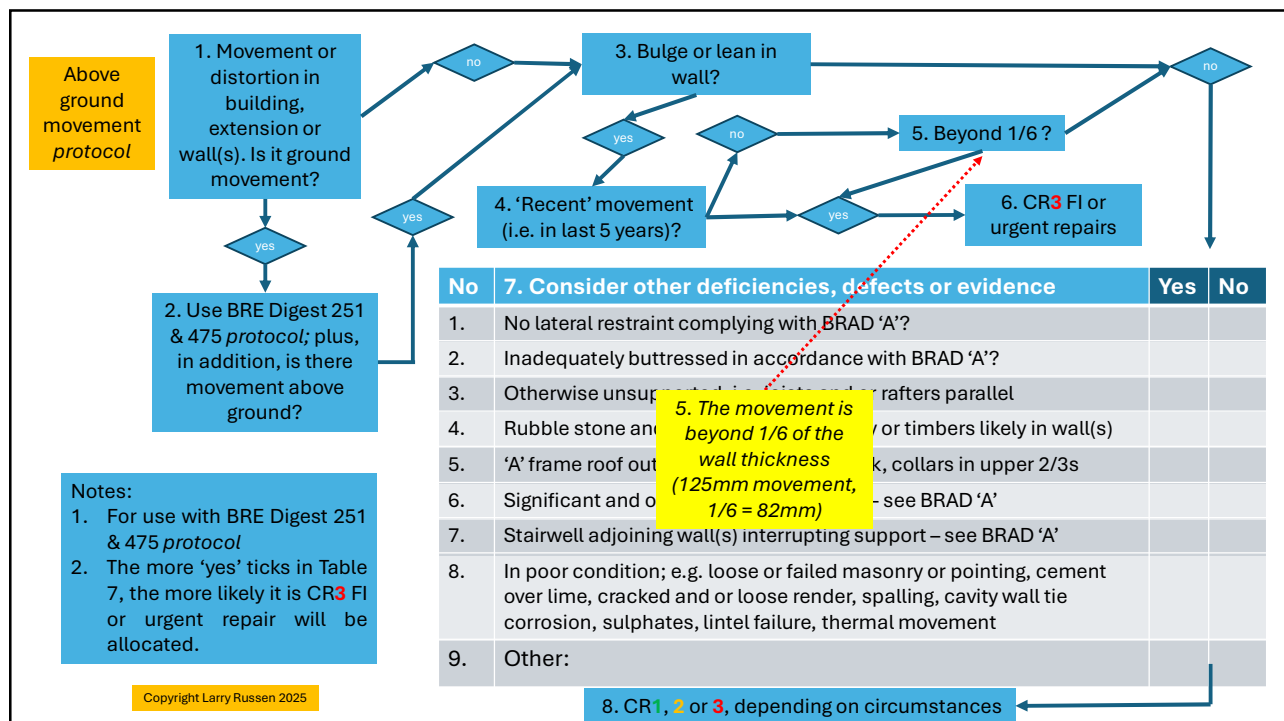
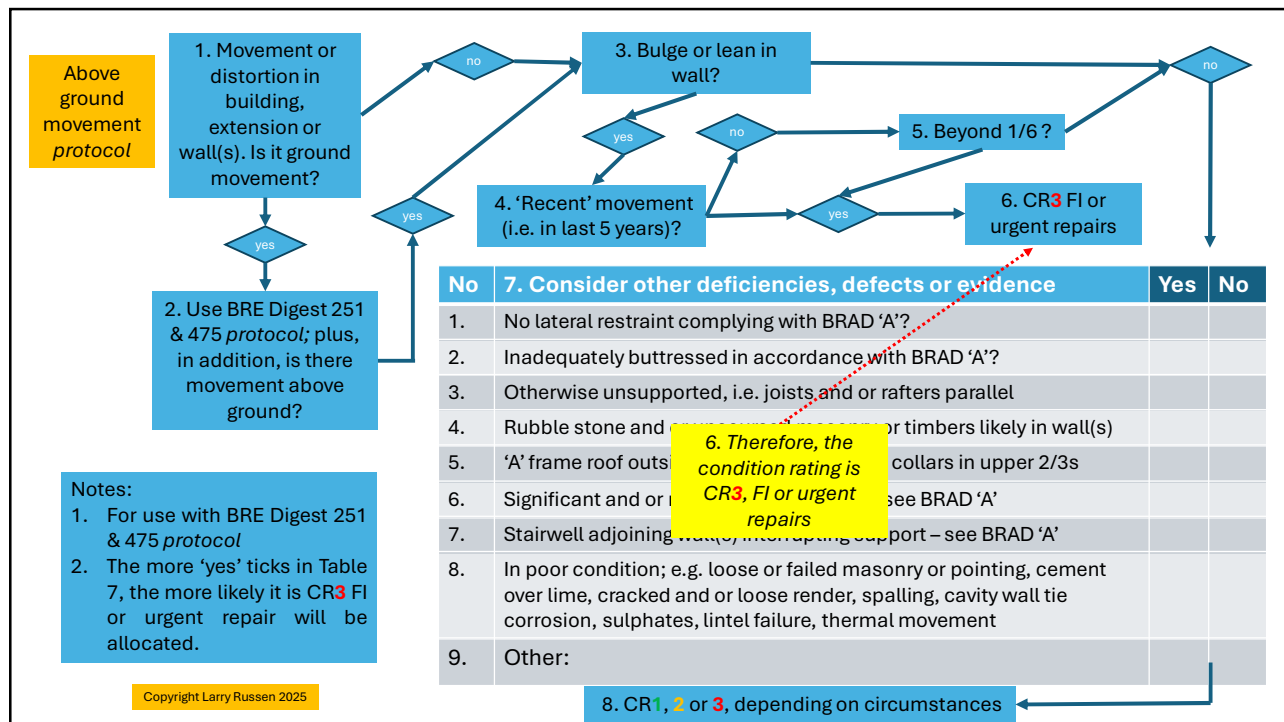
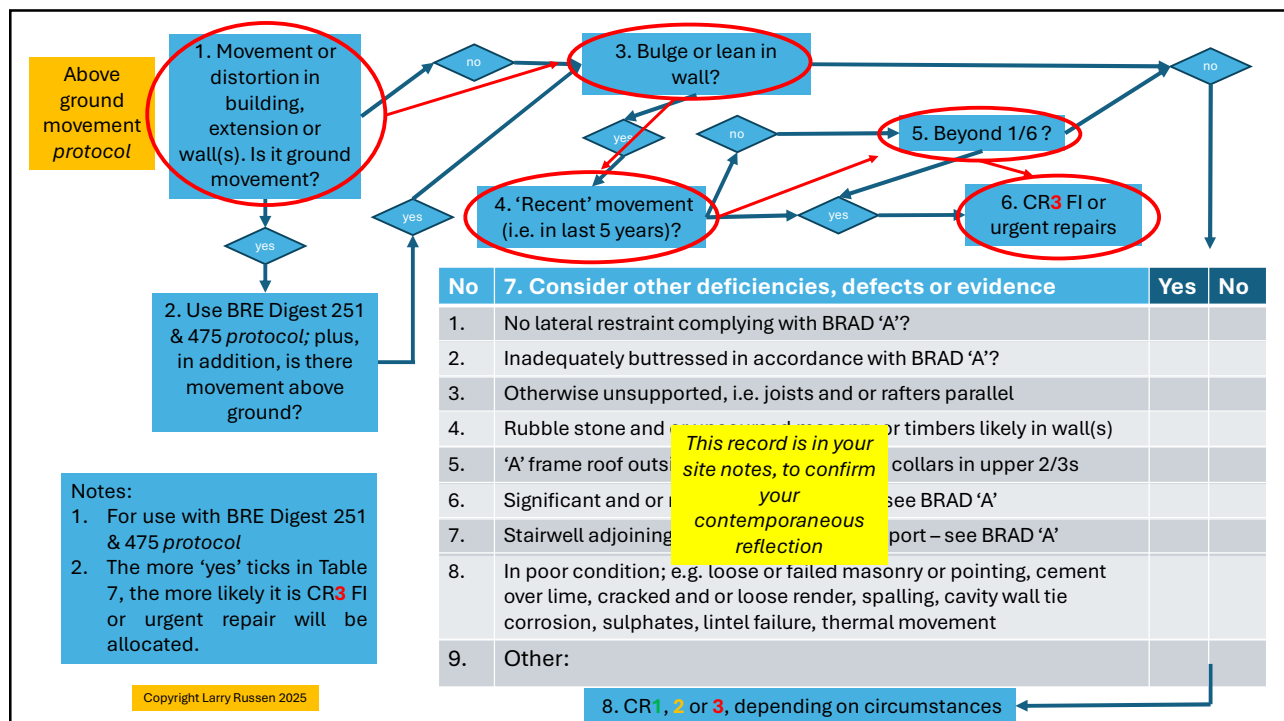
Cause of the movement – case study 1

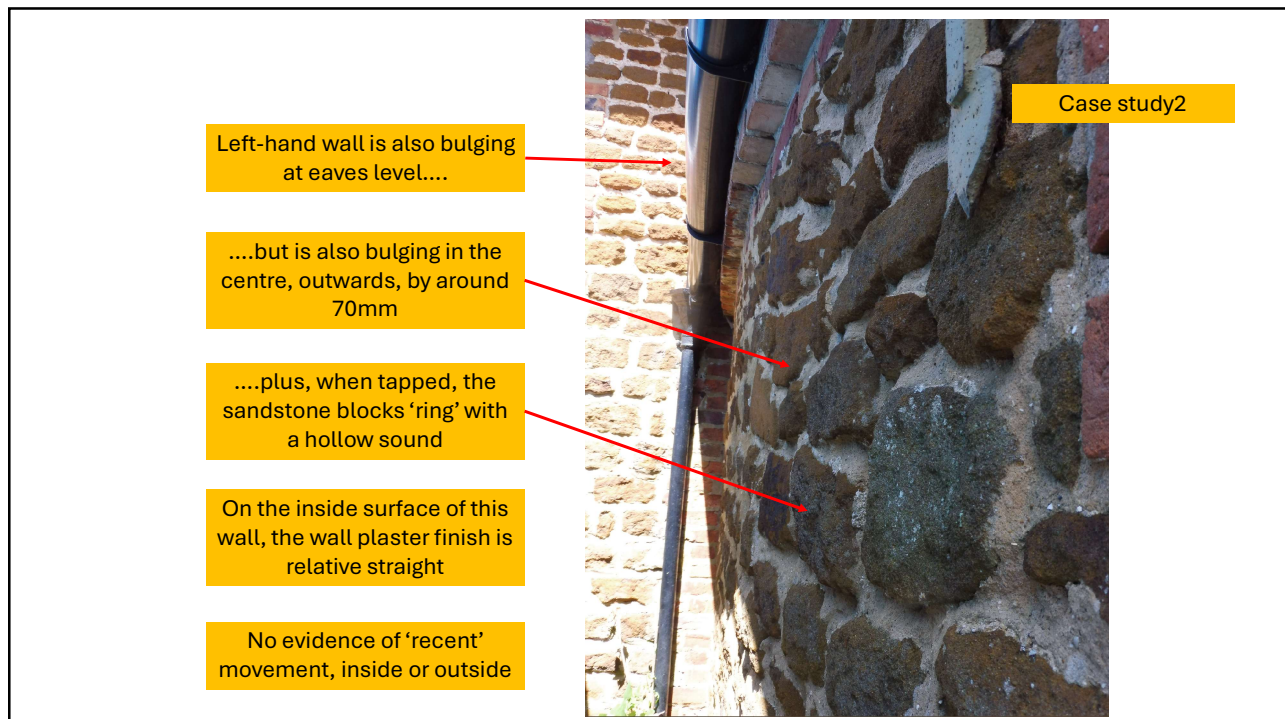
Defects noted

Case study 2

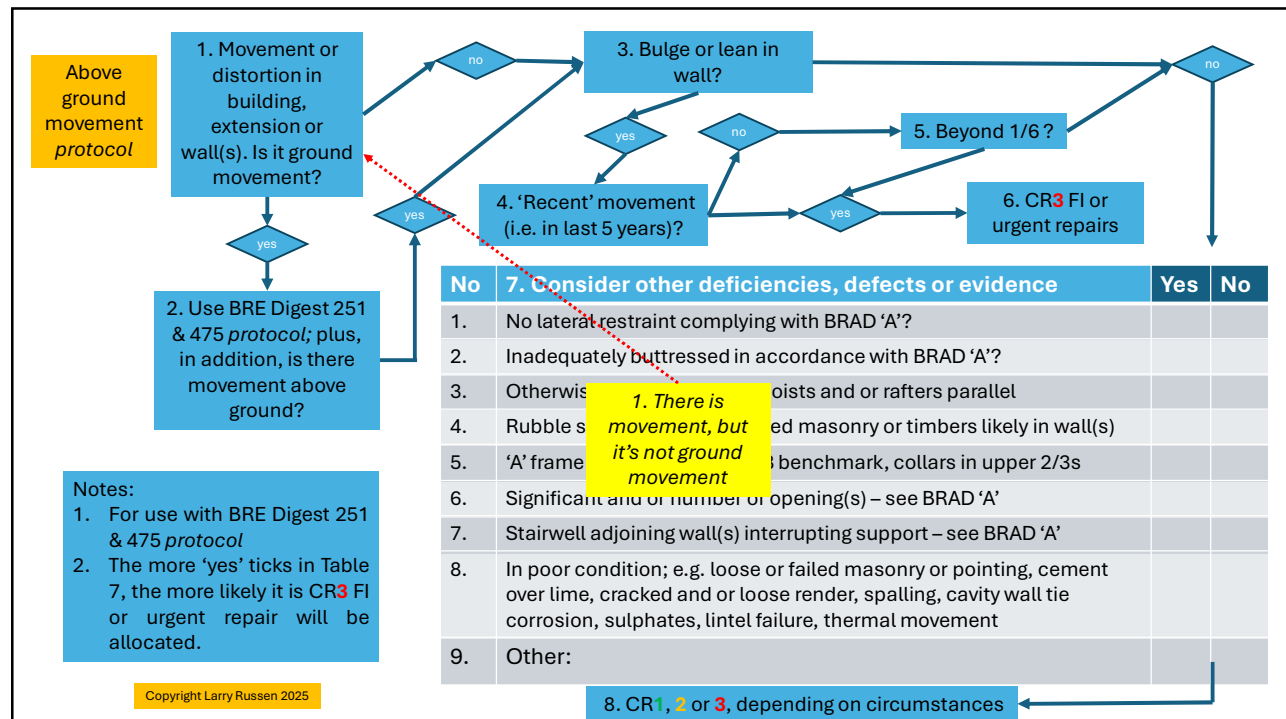
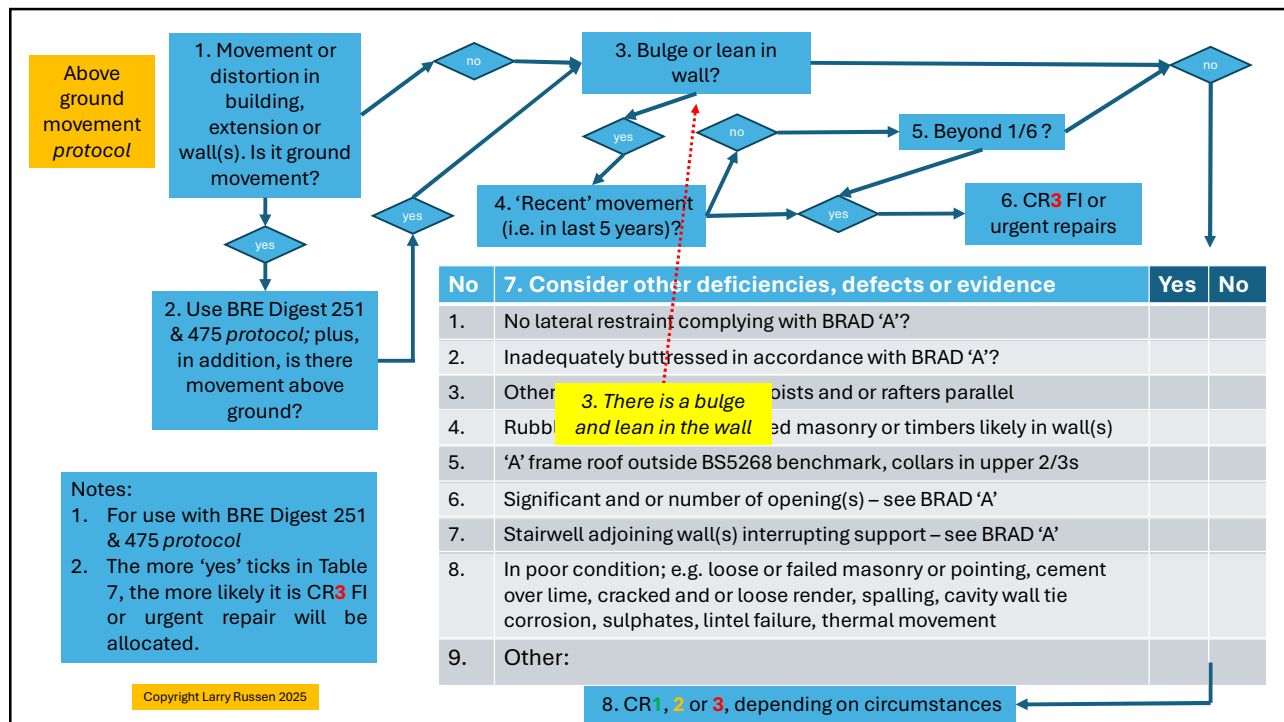
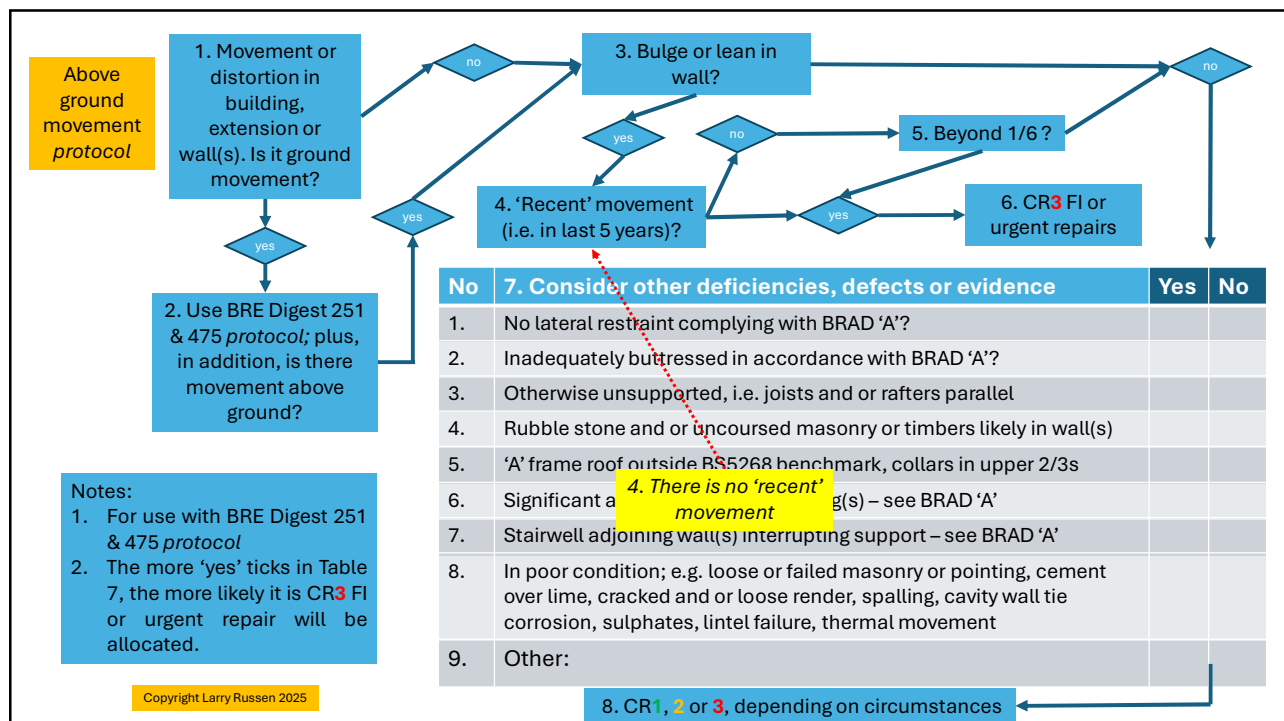
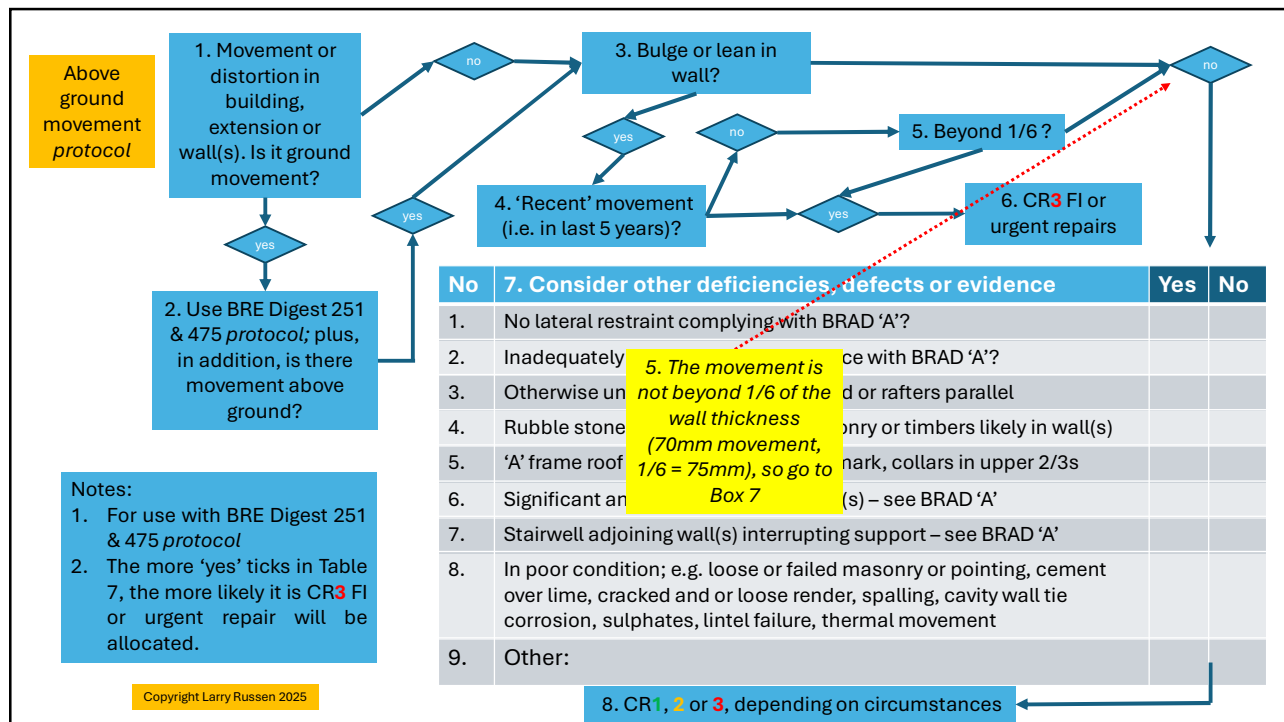
No	7. Consider other deficiencies, defects or evidence	Yes	No
1.	No lateral restraint complying with BRAD 'A'?	✓	
2.	Inadequately buttressed in accordance with BRAD 'A'?		✓
3.	Otherwise unsupported, i.e. joists and or rafters parallel		✓
4.	Rubble stone and or uncoursed masonry or timbers likely in wall(s)	✓	
5.	'A' frame roof outside BS5268 benchmark, collars in upper 2/3s	✓	
6.	Significant and or number of opening(s) – see BRAD 'A'		✓
7.	Stairwell adjoining wall(s) interrupting support – see BRAD 'A'		✓
8.	In poor condition; e.g. loose or failed masonry or pointing, cement over lime, cracked and or loose render, spalling, cavity wall tie corrosion, sulphates, lintel failure, thermal movement	✓	
9.	Other:		✓

- The roof structure is not ‘triangulated’;
- The ‘A’ frame roof structure has distorted and has thrust outwards;
- Thereby causing the top of the wall to bulge; and
- The wall generally to lean... however, in addition
- The sandstone blocks have loosened away from the chalk inside (‘de-bonded’), possibly affected by sulphates from the chimney breast; so
- Movement is likely to progress, i.e. get worse; thus
- **Condition rating 3.**

The left-hand wall of the front extension is showing signs that parts of the wall are bulging and parts are loose. This type of problem is usual in old walls of rubble stone construction. It usually occurs when the walls have been subjected to water penetration, or when water has been running down from defective roofs or rainwater fittings. Water penetrates into the wall and causes disturbance in the different types of building material including the old mortar within the wall. The problem can be worse if there are different types of stone in the wall, as appears to be the case with this property. This causes the materials to break apart. Over time this can create hollow areas in the wall, and the outer part of the wall can fall away.

The problem may have been made worse due to the fact the wall originally had a working chimney stack built into it. The old flue lining will probably have been a coating of sand and lime applied to the internal surface of the flue. This coating will have failed many years ago and masonry at the back (left-hand side) of the stack will therefore have been exposed. This can allow salts from condensation, together with soot and tar from wood and coal to contaminate the surrounding walls. This can cause significant deterioration in the internal construction of a chimney stack and any adjacent wall. The centre of the wall has bulged significantly, by around 70mm. The wall needs to be strengthened now, probably by using a proprietary system such as that developed by a company called 'Helifix'. This system usually includes a combination of stainless-steel ties and reinforcing rods and special epoxy glue (called 'resin bonding'). This reinforcement bonds the materials in the wall together and creates a 'beam' system. Condition rating **3**.
